FERC No. 2628

April 2021

The goals of this study were to identify any problematic erosion sites and sedimentation areas and determine the likely causes.

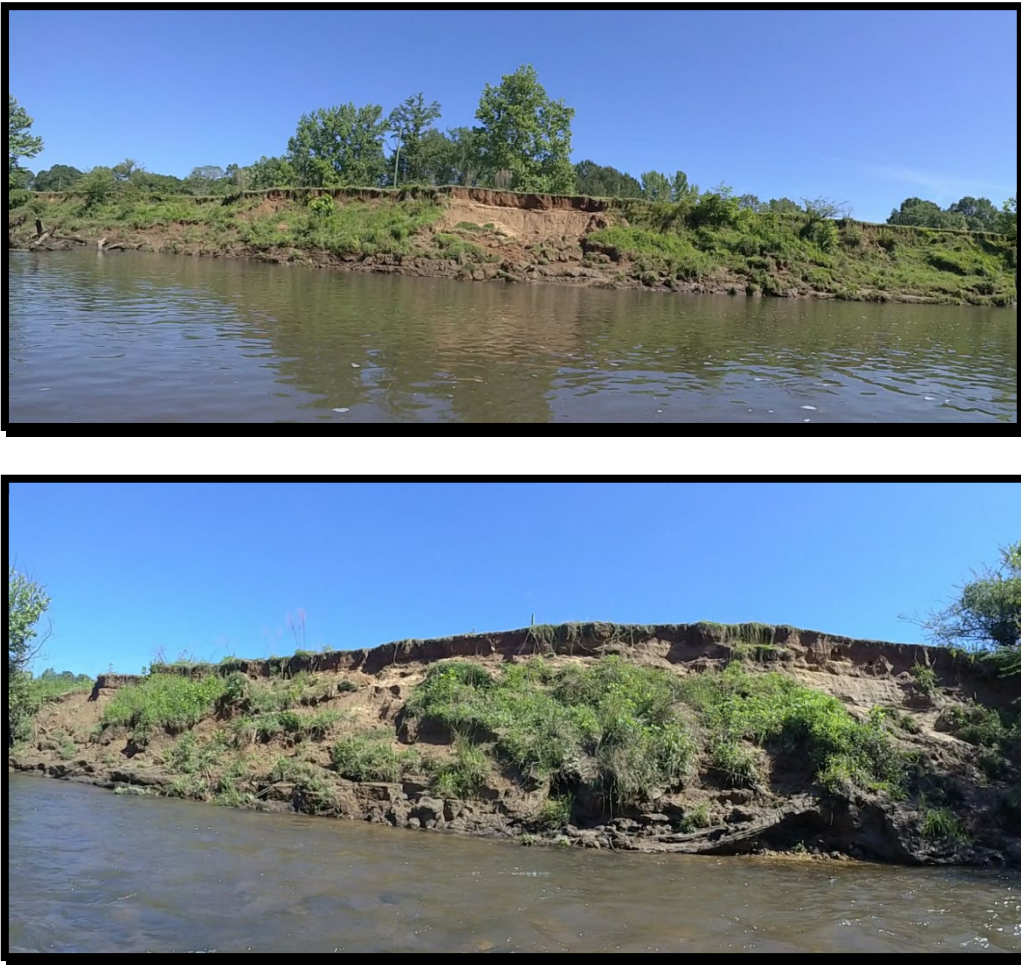
Interestingly, only one area scored as impaired to non-functional. This area was located on the right bank between river mile 16.3 to 16.9 (Figure 30). This is a very positive finding as many rivers we have surveyed in the Southeastern US have much more extensive bank erosion issues.

Figure 30: Example images of worst area on right bank of the Tallapoosa River between river mile 16.3 and 16.9.
