FERC No. 2628

April 2021

The goals of this study were to identify any problematic erosion sites and sedimentation areas and determine the likely causes.

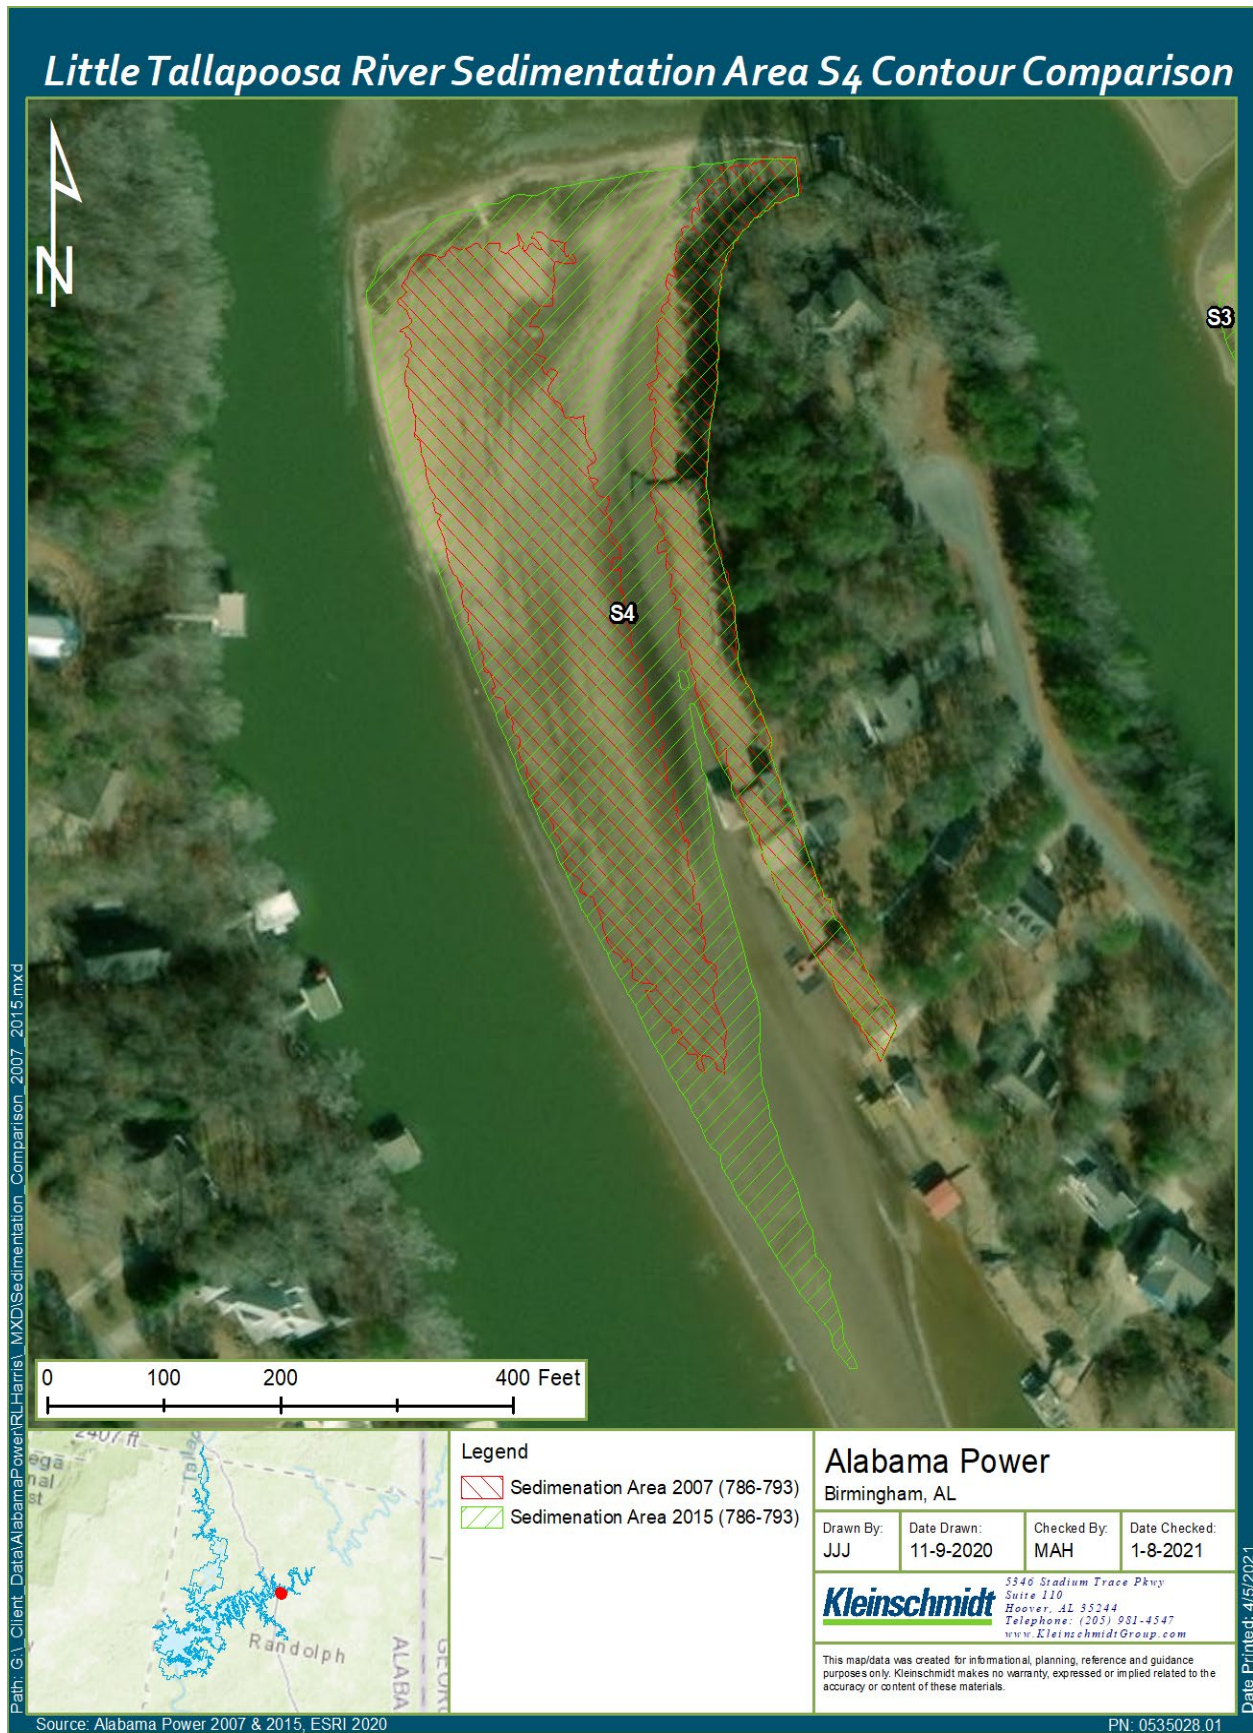
FIGURE 2-13 SEDIMENTATION AREA S4

Name	2007 Acreage	2015 Acreage	Change (acres)	Change (%)
S1	19.28	19.86	0.58	3
S2	1.29	1.65	0.36	28
S3	5.40	6.09	0.69	13
S4	2.47	3.99	1.51	61
S5	1.51	4.11	2.60	172
S6	5.55	6.12	0.57	10
S7	16.47	17.70	1.23	7
S8	10.08	9.65	-0.42	-4
S9	11.44	11.69	0.26	2

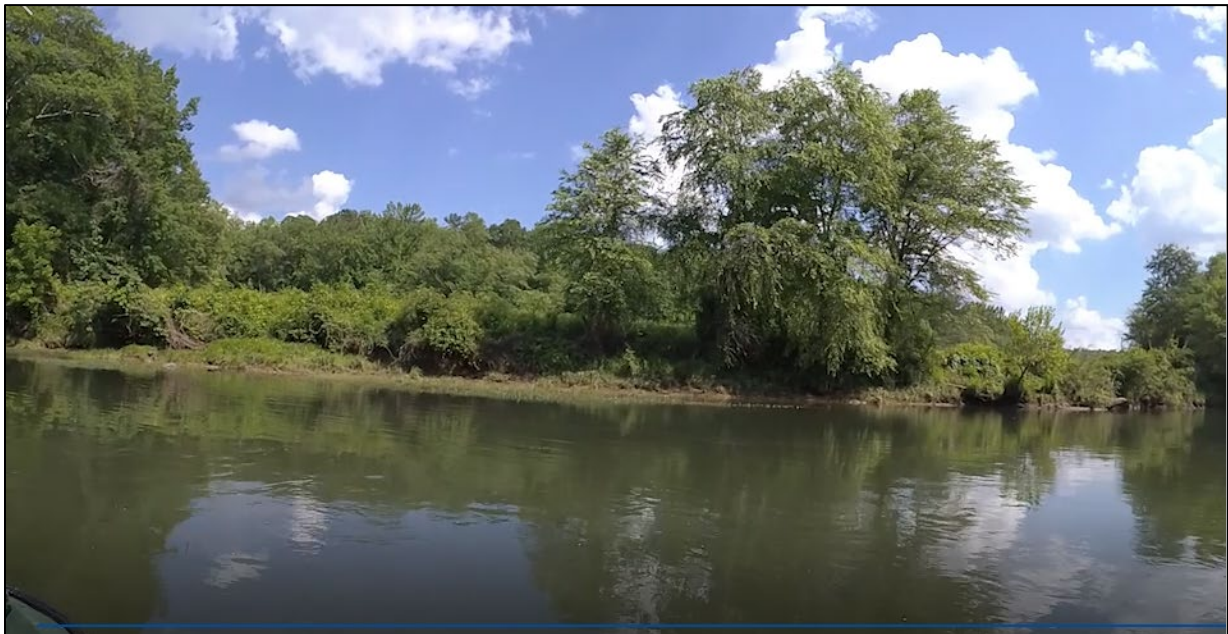
FIGURE 3-4 EROSION SITE 23 – IMAGE CAPTURE FROM HDSS SURVEY VIDEO

The downstream survey results included conditions for erosion sites 22 and 23 shown in Figure 2-5. These sites were also assessed using the same criteria as the erosion sites located within Lake Harris (Appendix C). Both sites were confirmed to have areas of erosion potentially caused by adjacent land use/clearing and riverine processes (Figure 3-3 and Figure 3-4). The streambank condition class for both areas was "slightly impaired," and confidence (i.e., clarity of the areas in the HDSS video used to assess streambank condition) was classified as "Good Visibility."

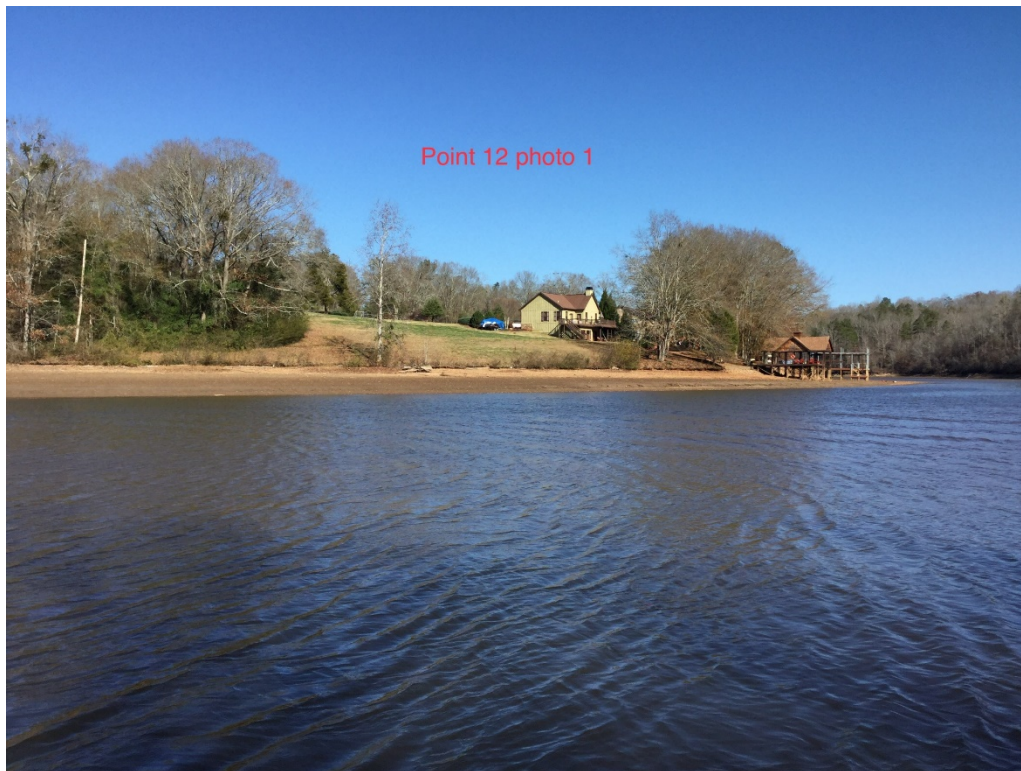
Erosion Site 12 – Lake Harris/Little Tallapoosa River

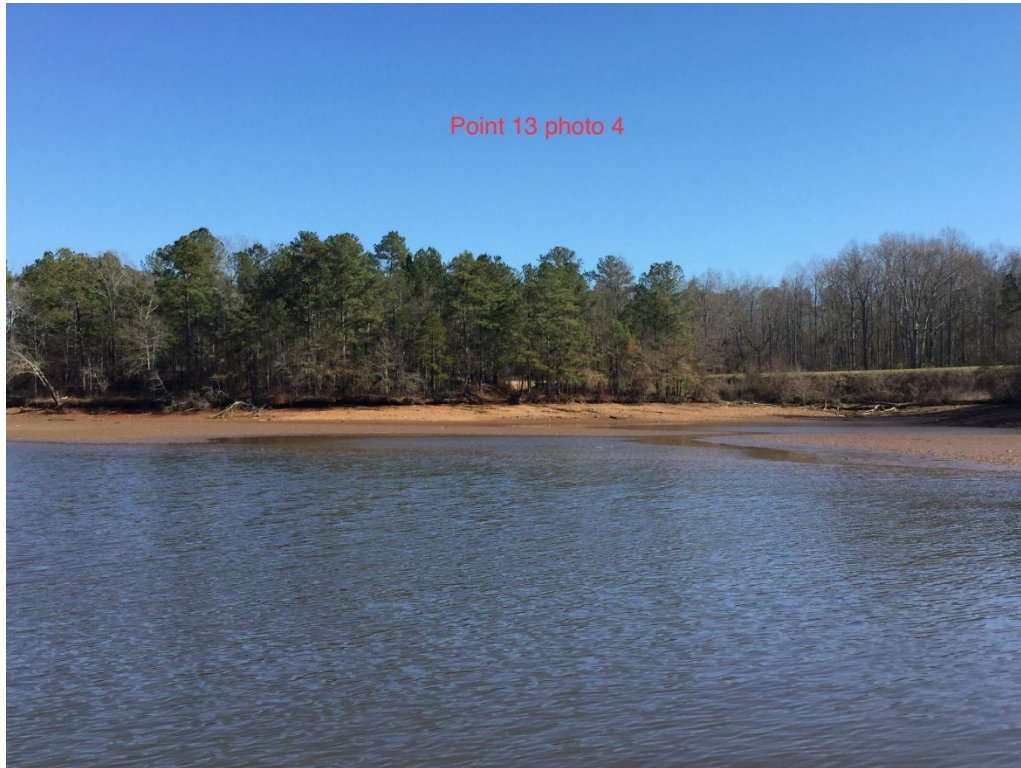
Erosion Site 13 – Lake Harris/Little Tallapoosa River at Old US 431

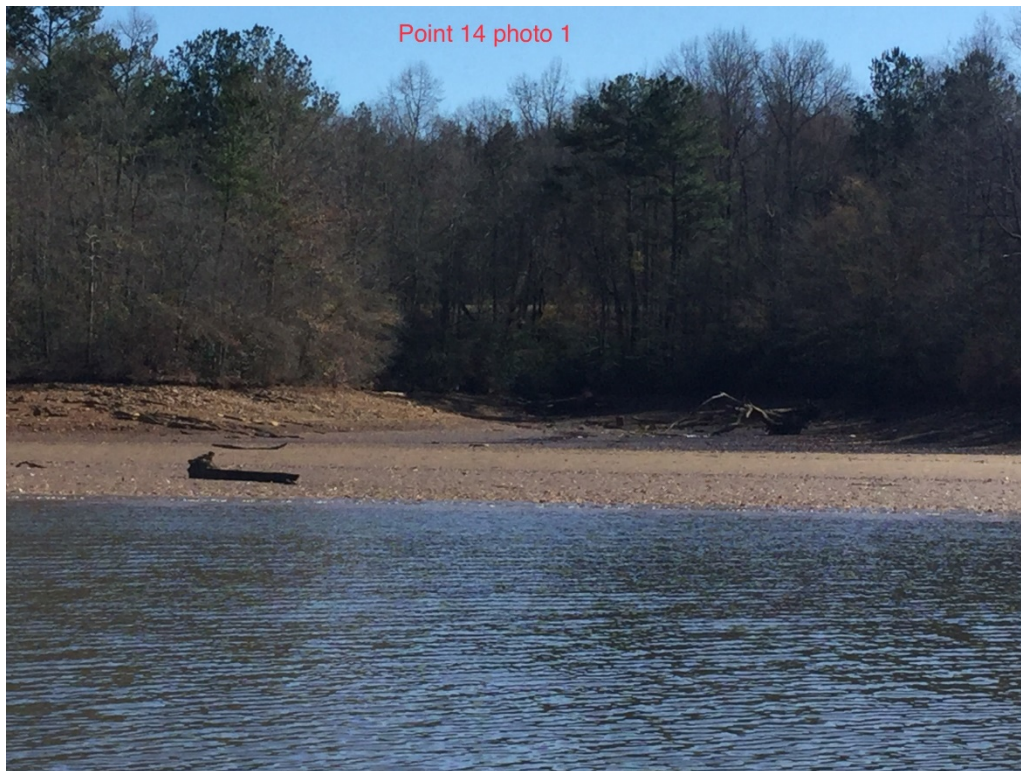
Erosion Site 14 – Lake Harris/Little Tallapoosa River at Old US 431

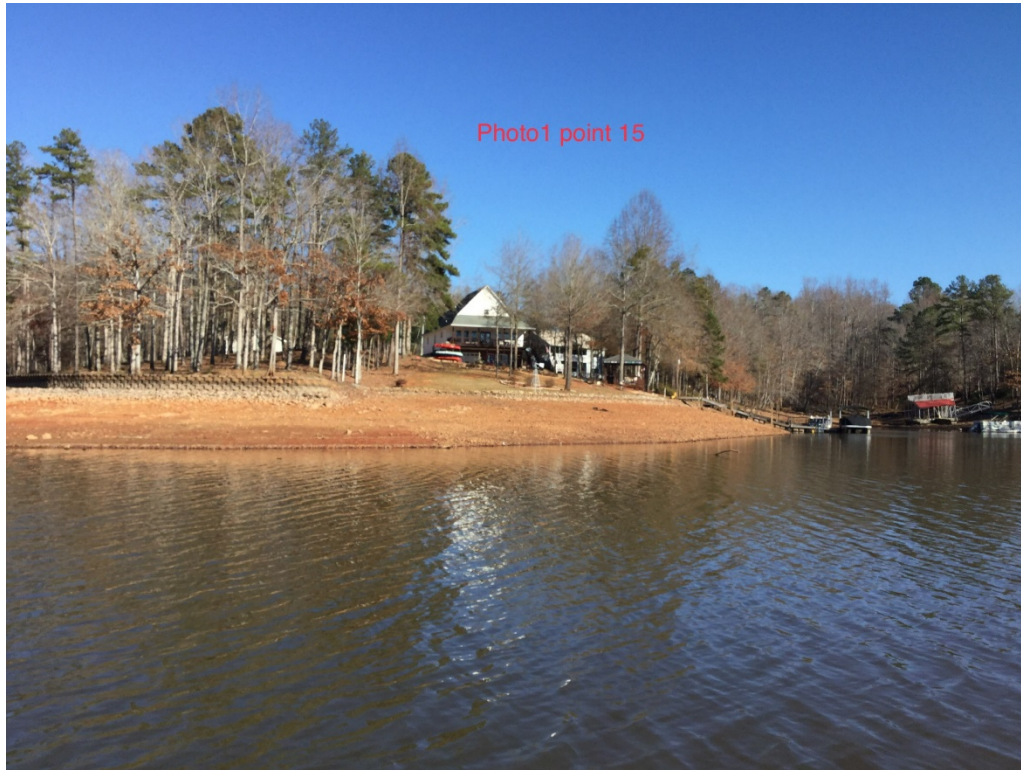
Erosion Site 15 – Lake Harris/Mud Creek

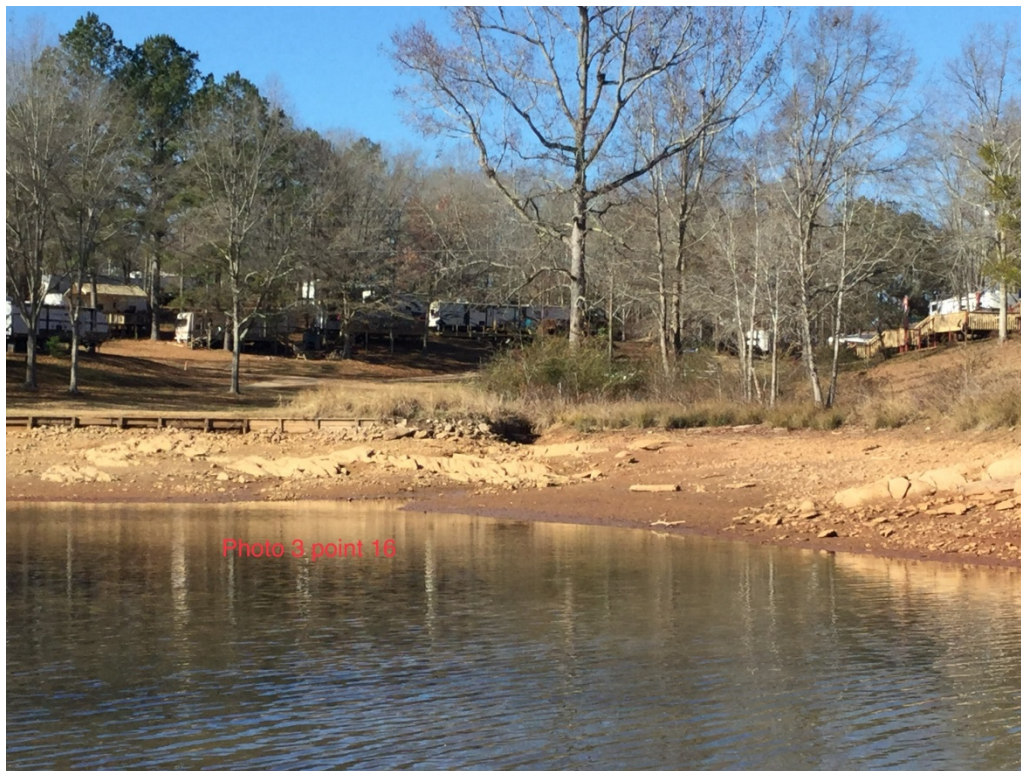
Erosion Site 16 – Lake Harris/Mud Creek

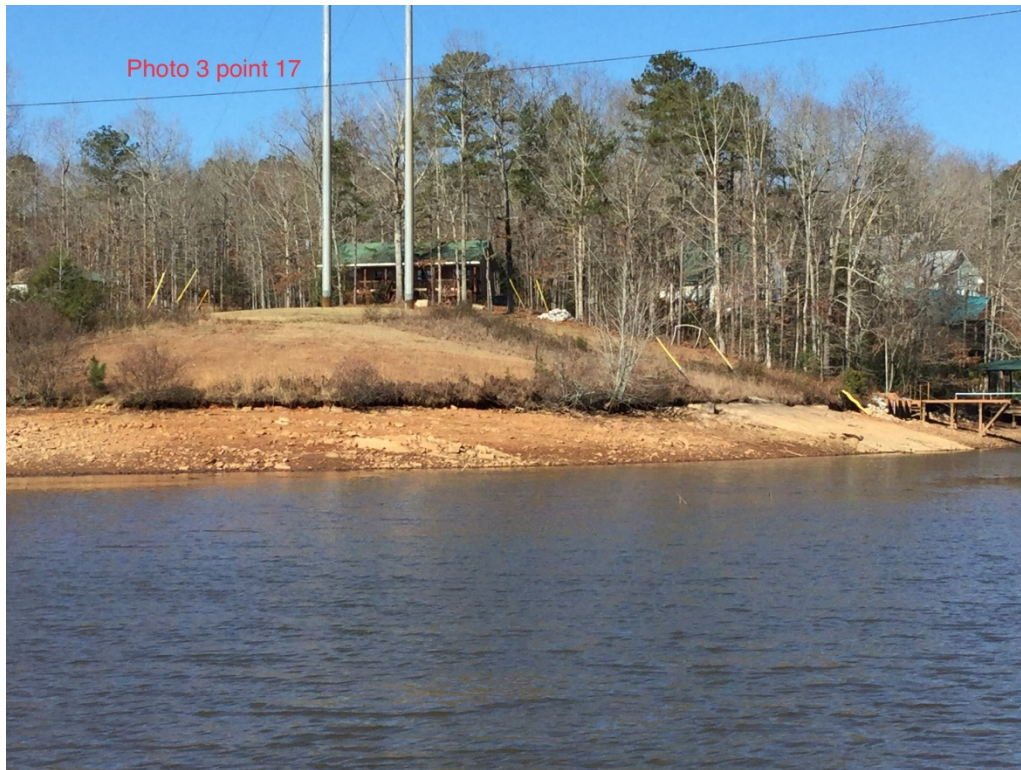
Erosion Site 17 – Lake Harris/Mud Creek

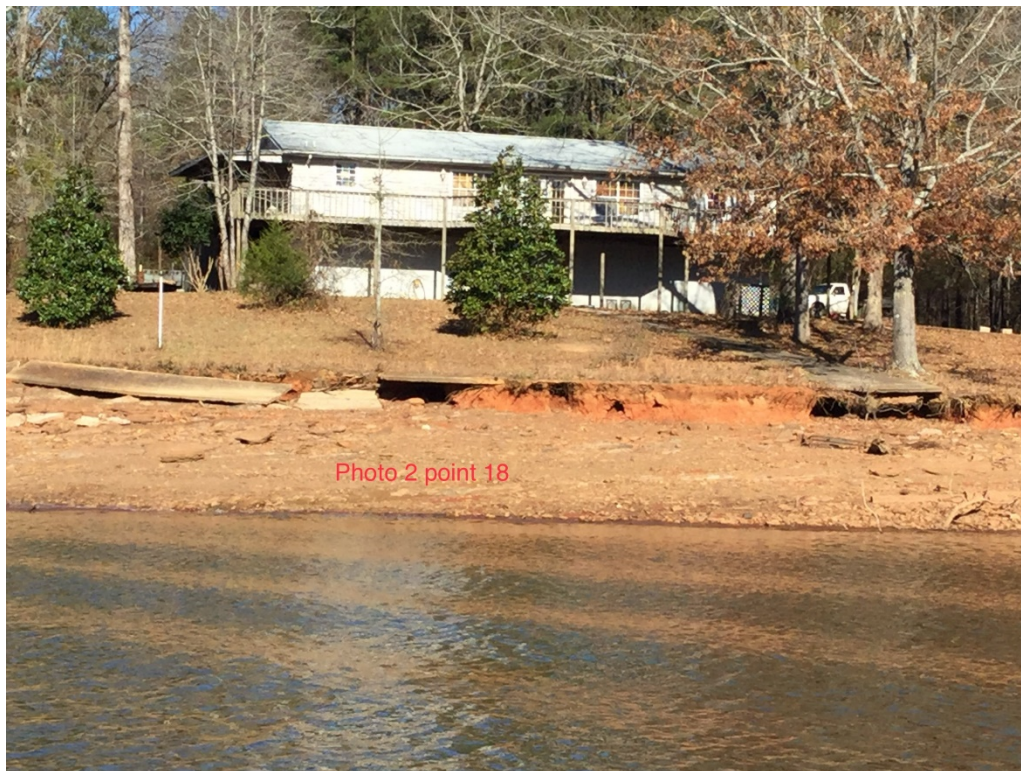
Erosion Site 18 – Lake Harris/Little Tallapoosa River

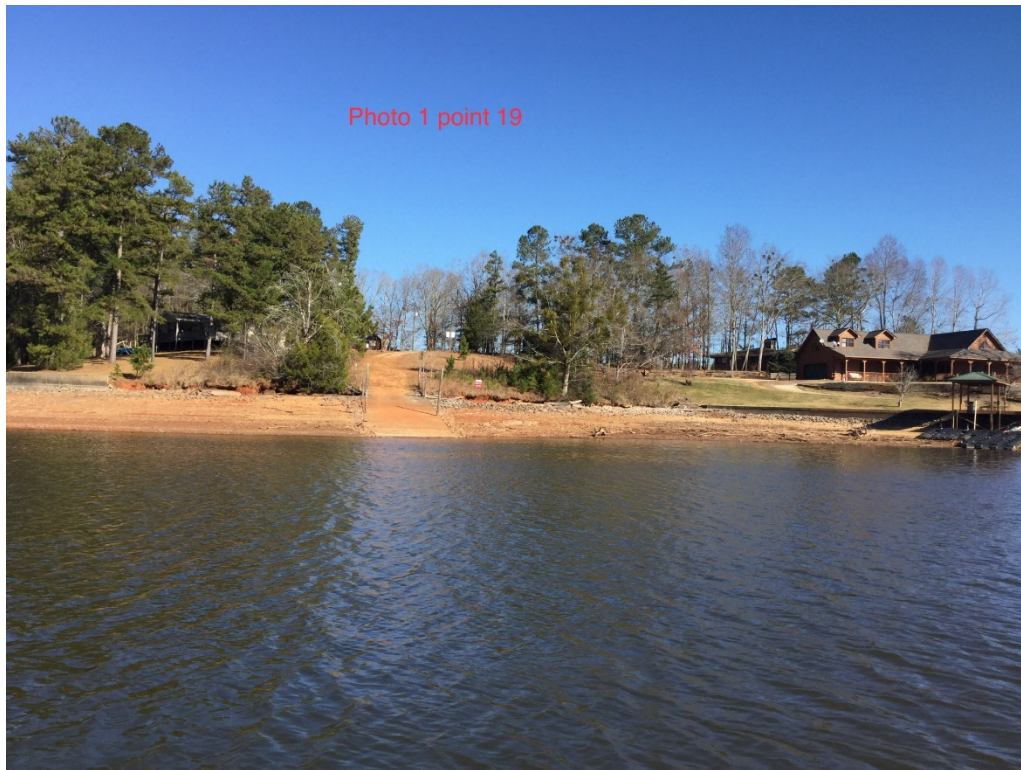
Erosion Site 19 – Lake Harris/Little Tallapoosa River

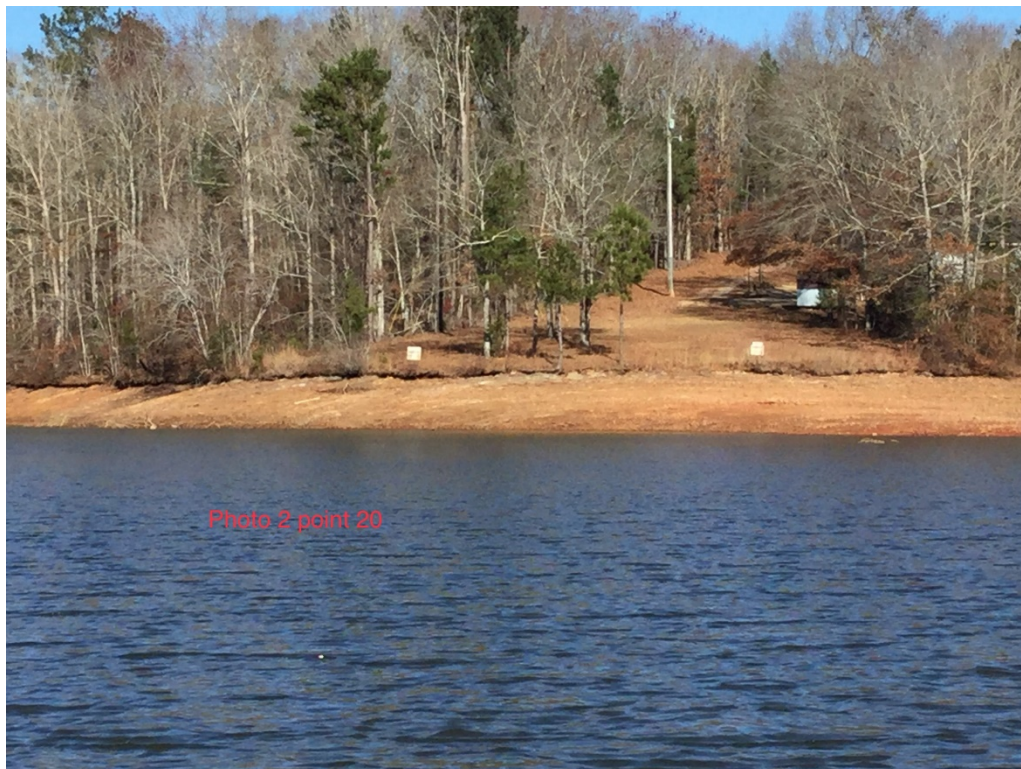
Erosion Site 20 – Lake Harris/Little Tallapoosa River

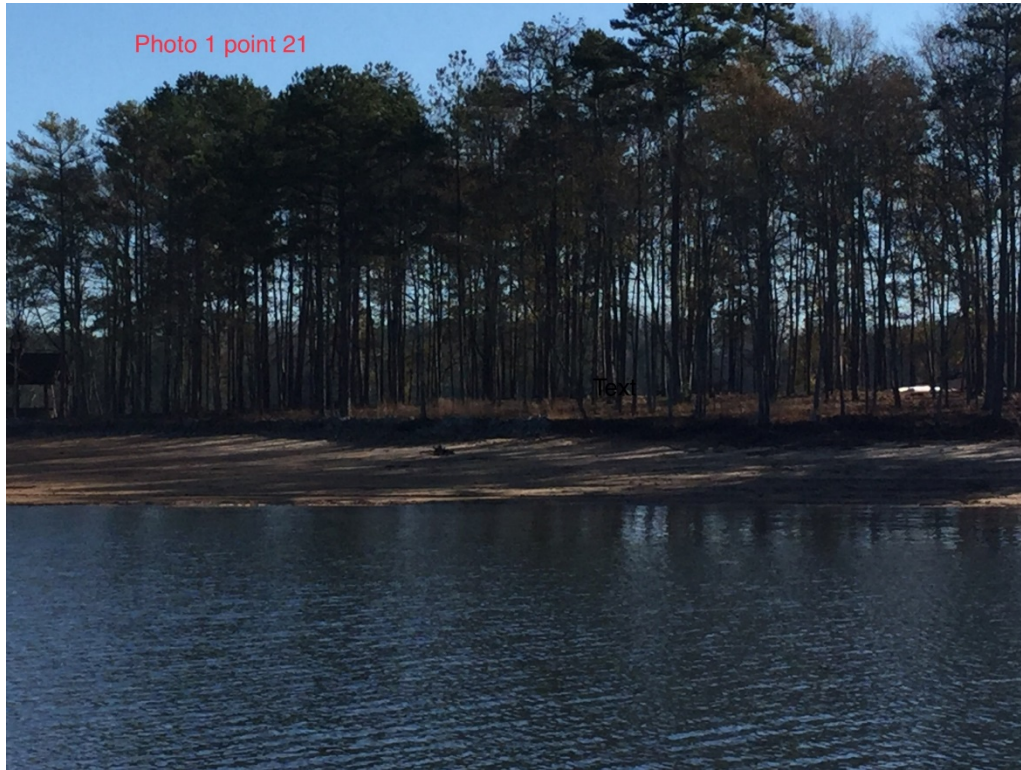
Erosion Site 21 – Lake Harris/Little Tallapoosa River

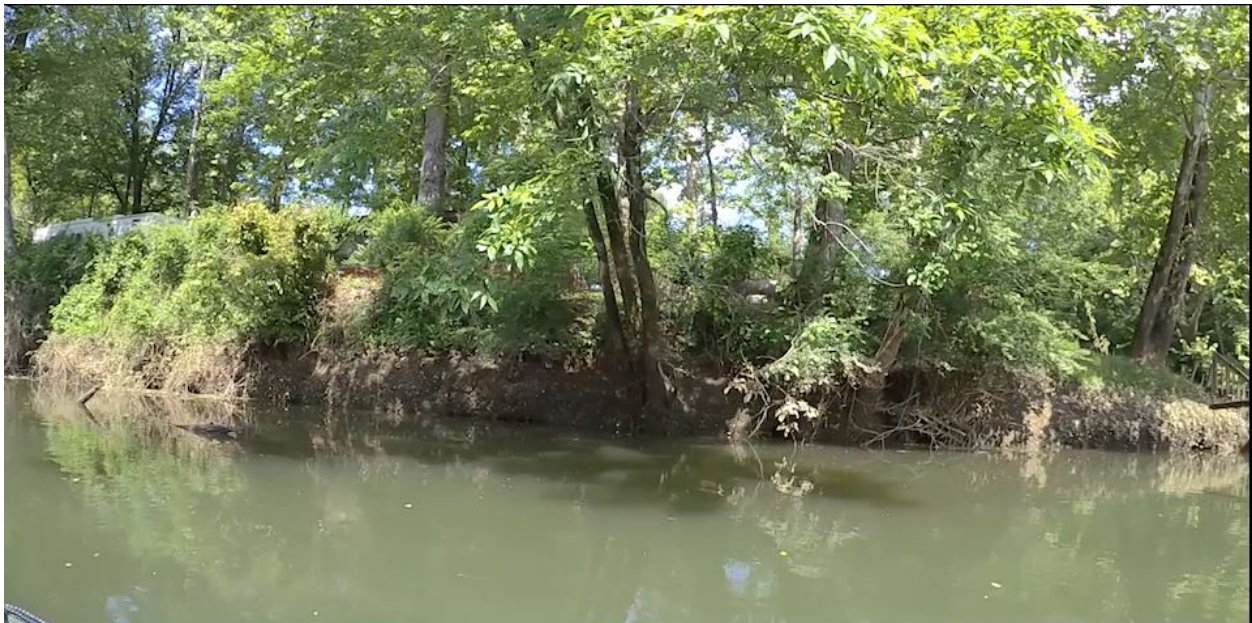
Erosion Site 22 – Tallapoosa River at Malone

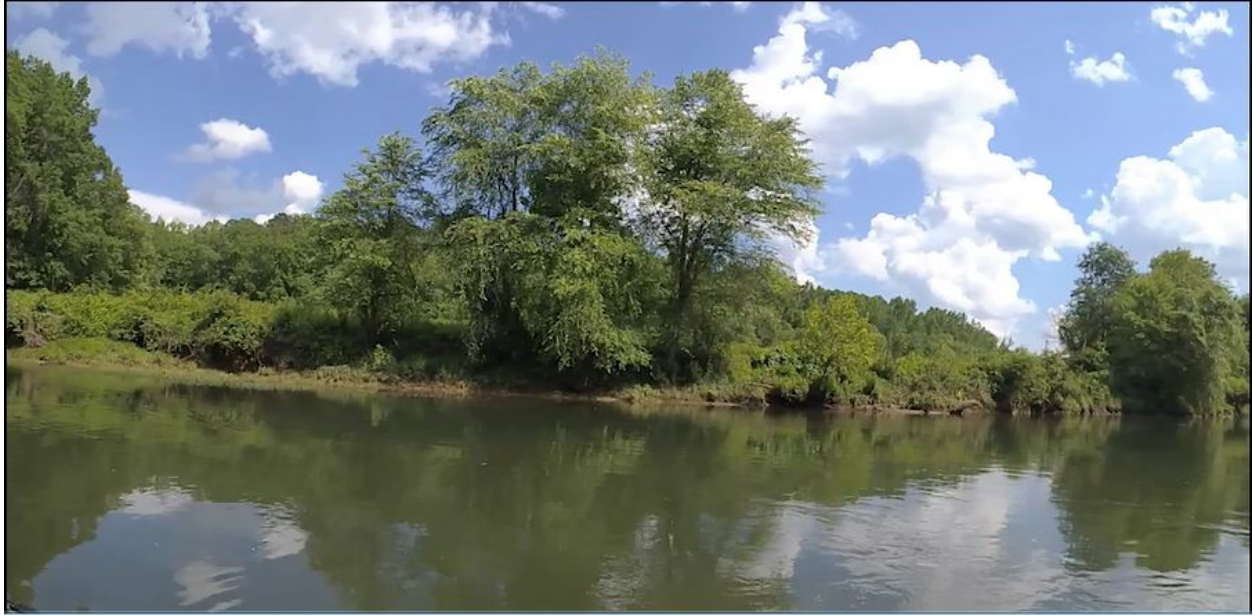
Erosion Site 23 – Tallapoosa River approx. 1-mile Below Malone

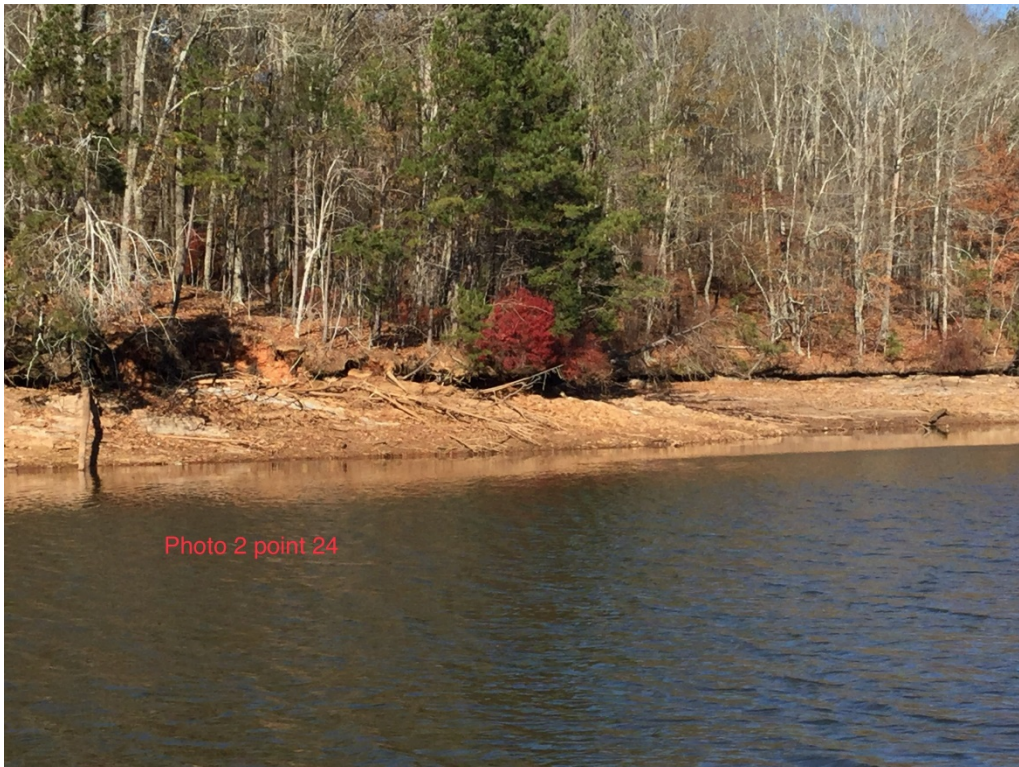
Erosion Site 24 – Lake Harris/Little Tallapoosa River

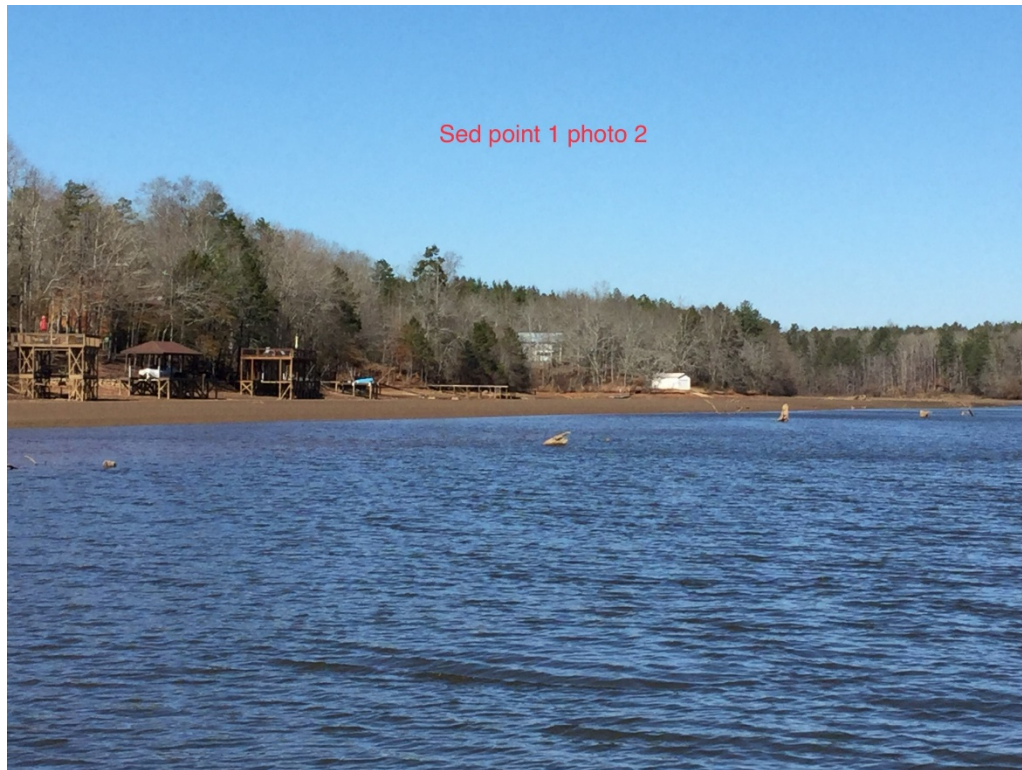
Sedimentation Site 1 – Lake Harris/Little Tallapoosa River

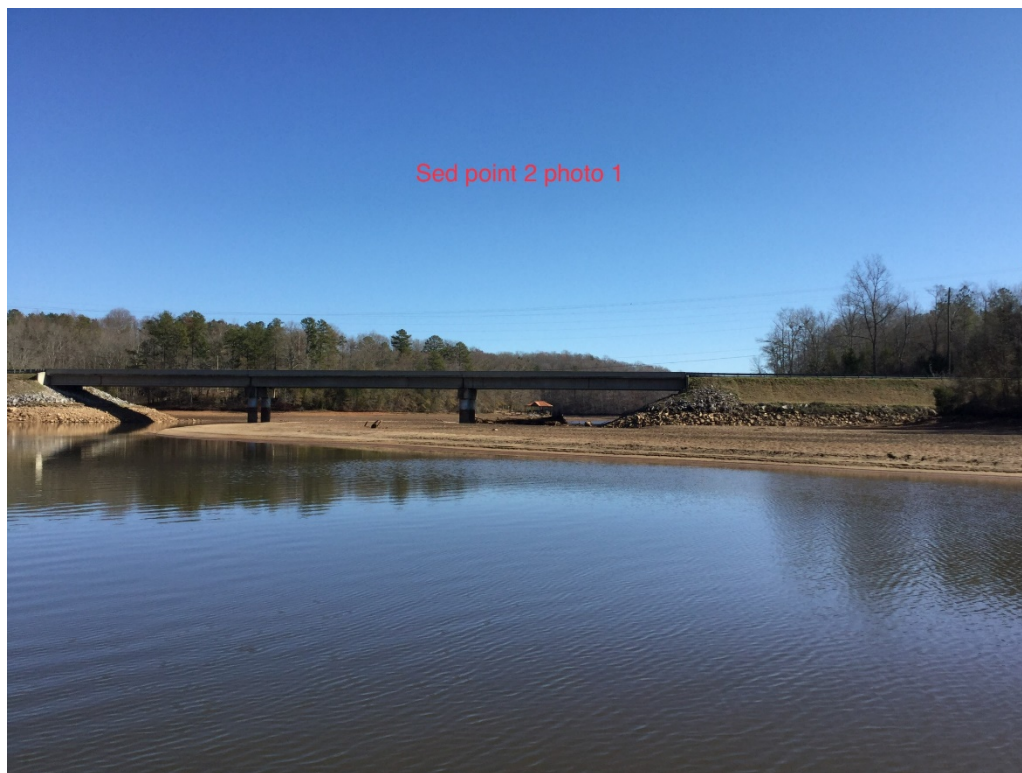
Sedimentation Site 2 – Lake Harris/Little Tallapoosa River

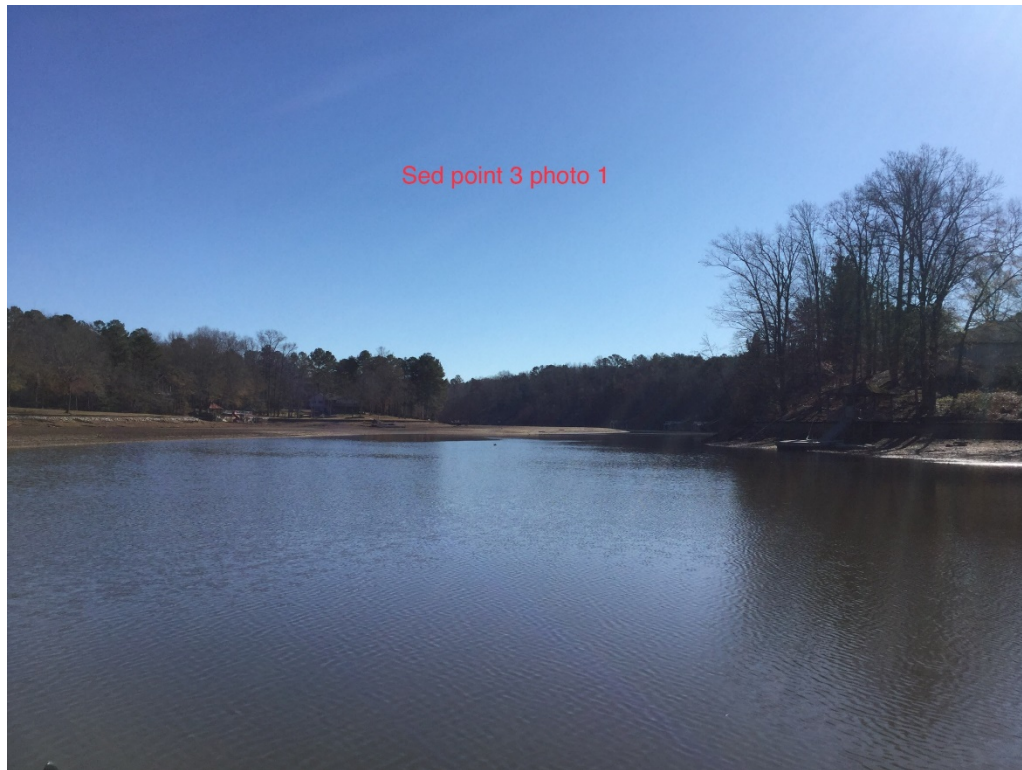
Sedimentation Site 3 – Lake Harris/Little Tallapoosa River

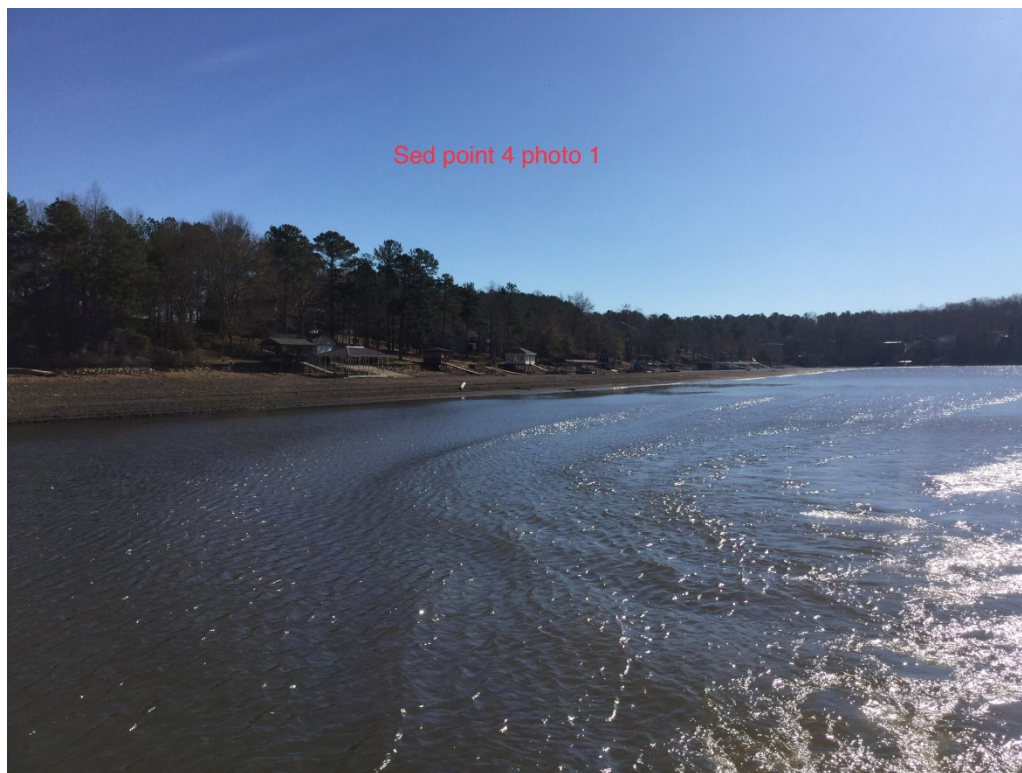
Sedimentation Site 4 – Lake Harris/Little Tallapoosa River

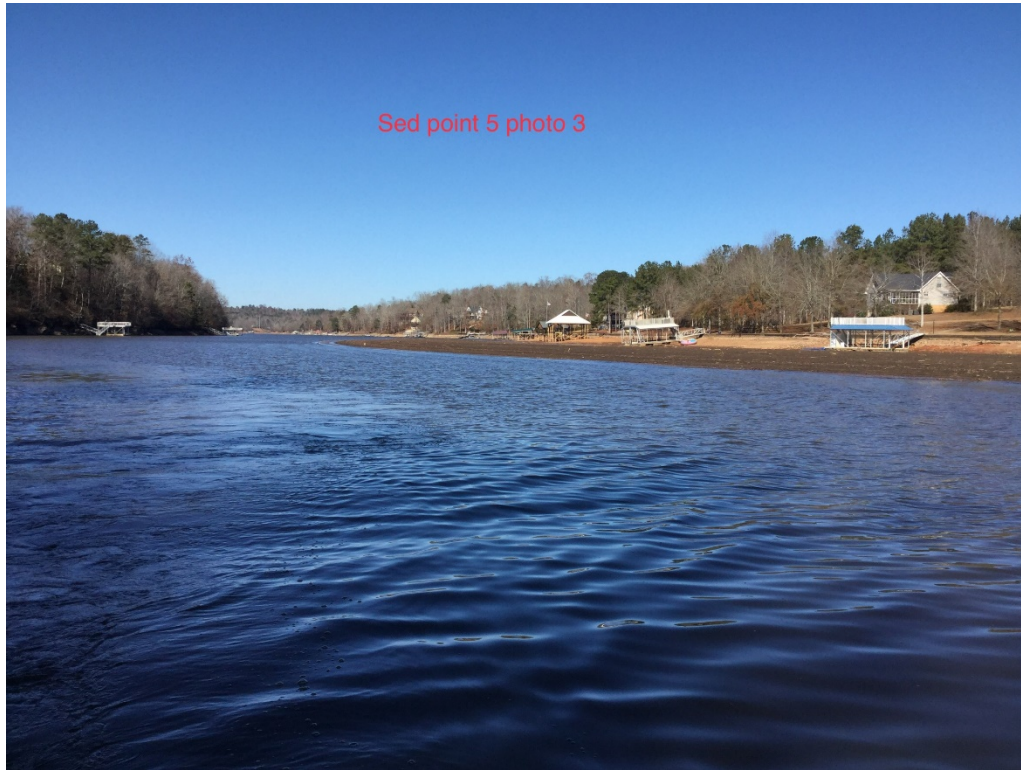
Sedimentation Site 5 – Lake Harris/Little Tallapoosa River

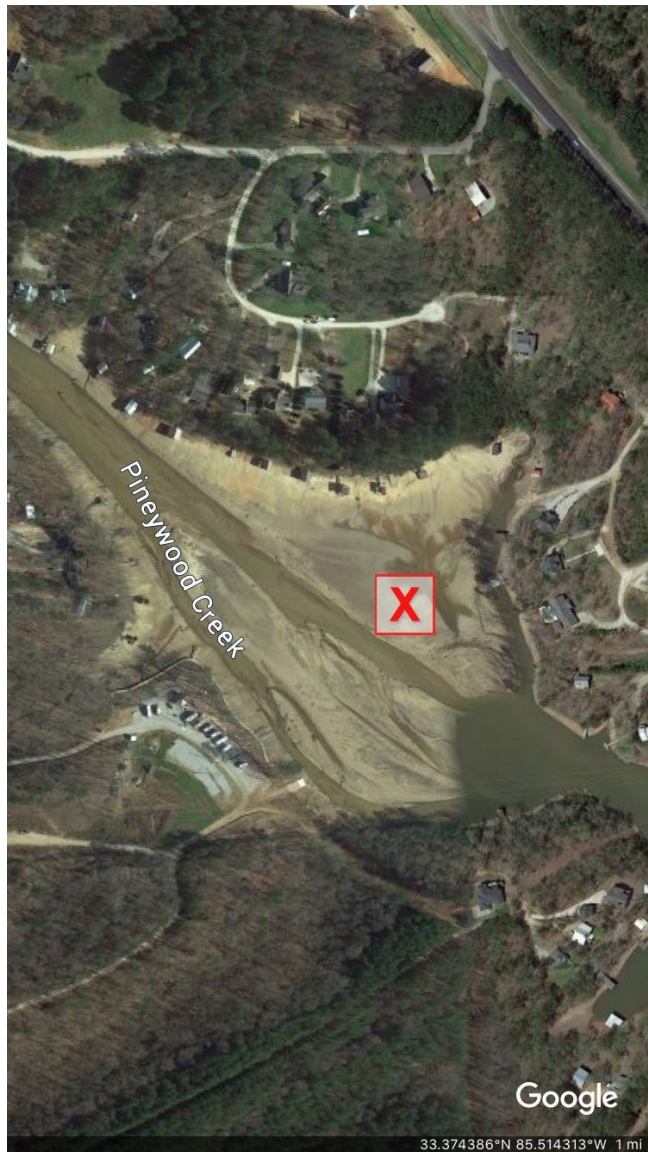
Sedimentation Site 6 – Lake Harris/Pineywood Creek

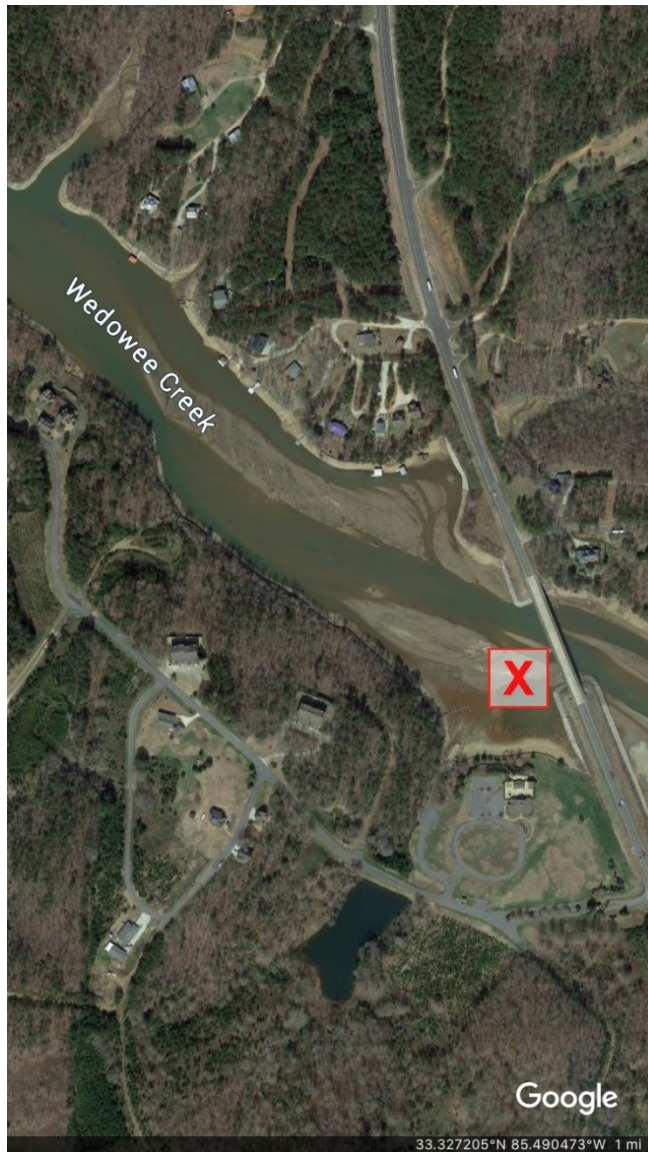
Sedimentation Site7 – Lake Harris/Wedowee Creek

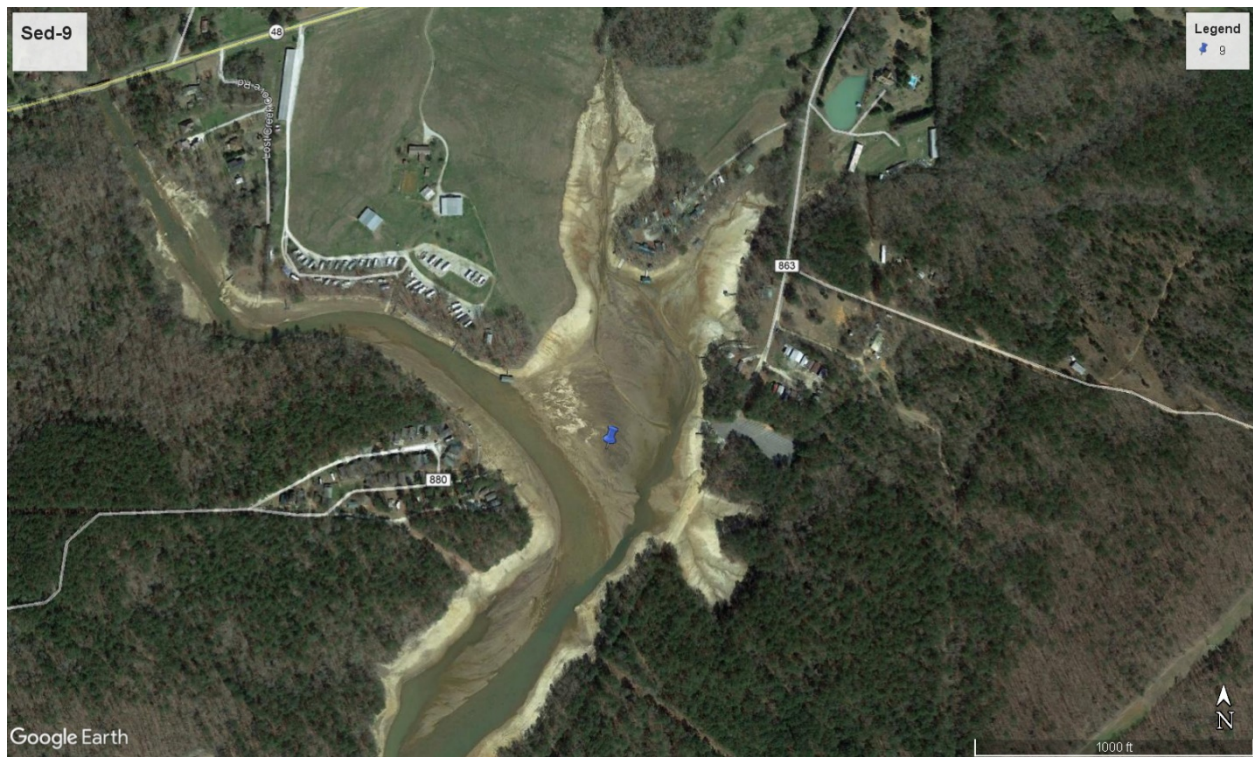
Sedimentation Site 9 – Lake Harris

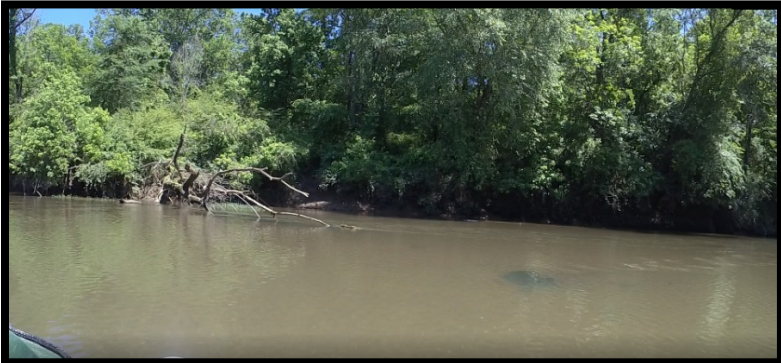
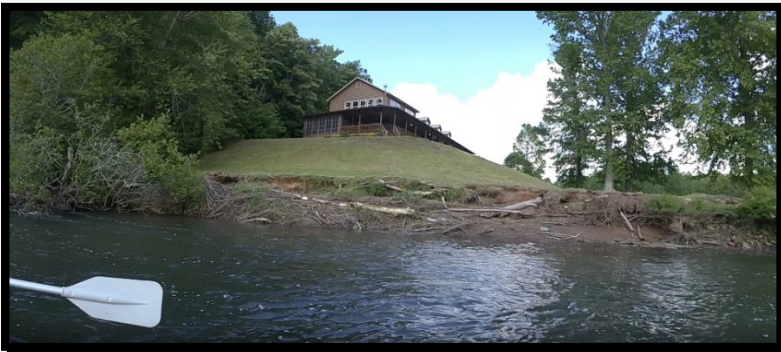
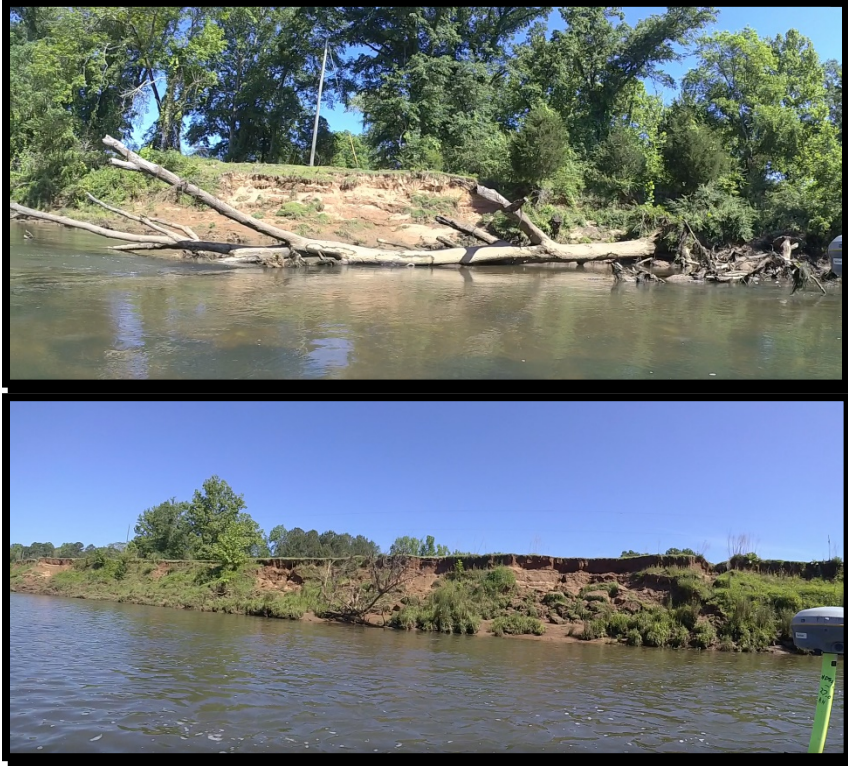
4: Impaired

5: Non-Functional

Figure 11: Examples from the Tallapoosa River survey of the five streambank impairment classification levels.
